NOAA DIVING PROGRAM SAFETY BULLETIN:

ATTENTION ALL DIVERS: A drysuit safety stand down is now in place.

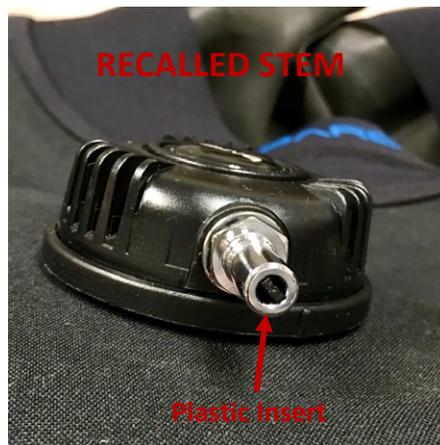
Figure 1.

Background: The NOAA Diving Center (NDC) recently had two incidents where the black plastic insert (Figure 1.) in new SiTech valves broke when the valves were attached and tested with the associated low pressure inflator hose. This caused the valves to fail and the divers were unable to add air to the drysuits. Lisa Glover, the Standard Equipment Program (SEP) technician is a certified SiTech valve technician. As a result of the failures she conducted inspections on other SiTech valves available at NDC across all brands of SEP drysuits. NDC found that drysuits with the same drysuit valve configuration had varying degrees of damage to the black plastic insert within the brass stem of the drysuit valve. This leads NDC to question the integrity of the drysuit valve.

Action: We are in communication with SiTech regarding the material failure and SiTech is providing replacement valve stems configured without the black plastic insert. Once received, we will notify all divers and arrange for units to send valves to NDC where staff will install the new valve stems according to manufacturer specifications and then return drysuit valves to the respective diving units.

All divers will inspect their drysuit valve and identify the valve stem configuration. If the black plastic insert is visible, do not use that valve. Do not attempt any field repairs or replacements. NDC will provide a valve replacement in accordance with manufacturer specifications and timing based on your mission essential requirements.

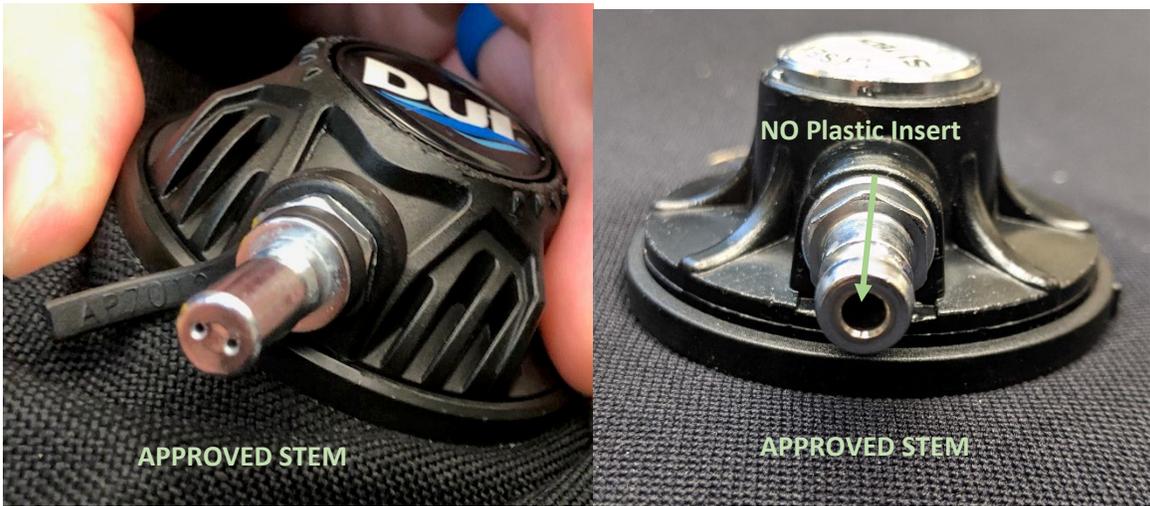
Figure 2.

Some drysuits may have a different style and manufacturer of valve with the two-hole configuration and completely hollow (no black plastic insert) configurations (Figure 2.). Valves with these stem configurations are still authorized for use. If you have any questions, please reach out to SEP.NDC@noaa.gov or call Lisa Glover directly.
