# SAFETY ALERT

## Technical Bulletin 07012020

### Subject: High-Pressure Gauges sold between 2012 and 2018

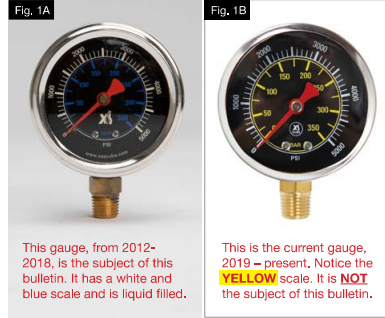
**How to Identify:** The GB01 HP gauges covered in this bulletin have a black face card with an outer psi scale in white, and an inner bar scale in blue. They are liquid-filled. They have 1/4" NPT threads (Fig. 1A). **DO NOT** confuse with the current GB01, 2019 – present, which has an outer psi scale in white, and an inner bar scale in yellow. It is not liquid-filled. This current gauge is **NOT** the subject of this bulletin (Fig. 1B).

Fig. 1A  
This gauge, from 2012-2018, is the subject of this bulletin. It has a white and blue scale and is liquid-filled.

Fig. 1B  
This is the current gauge, 2019 – present. Notice the **YELLOW** scale. It is **NOT** the subject of this bulletin.

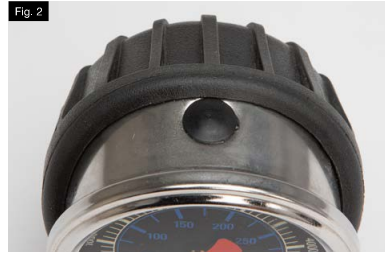
**The Problem:** In the rare event of an internal leak, the black over-pressure (OP) relief plug (Fig. 2), located on top, should vent, allowing excess pressure to escape. It does not in all cases.

We are finding that as these over-pressure plugs age, they are becoming harder. While originally supple and pliable, some that have been in the field for many years have become hard. In some cases, we found that the plug had become too hard to properly relieve excess pressure should there be an internal leak. This can result in the glass lens shattering outward.

**The Solution:** XS Scuba has a replacement OP plug available, which will not harden with age. To visually distinguish the two, the upgraded replacement plug is blue, while the old plug was black (Fig. 3).

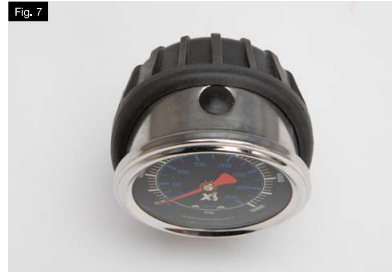
Email a simple picture, taken with your phone, of each suspect HP gauge in your possession. Peel back the rubber protective boot, exposing the OP Plug. Shoot the gauge from the front, at a sharp downward angle (Fig. 7). The image should show the front face card, the black OP plug, and the top of the rubber protective boot.
